**UNITED STATES DISTRICT COURT
NORTHERN DISTRICT OF CALIFORNIA**

| Plaintiffs, |) | COMPLAINT AND |
| |) | DEMAND FOR JURY TRIAL |
| CHART INC. |) | |

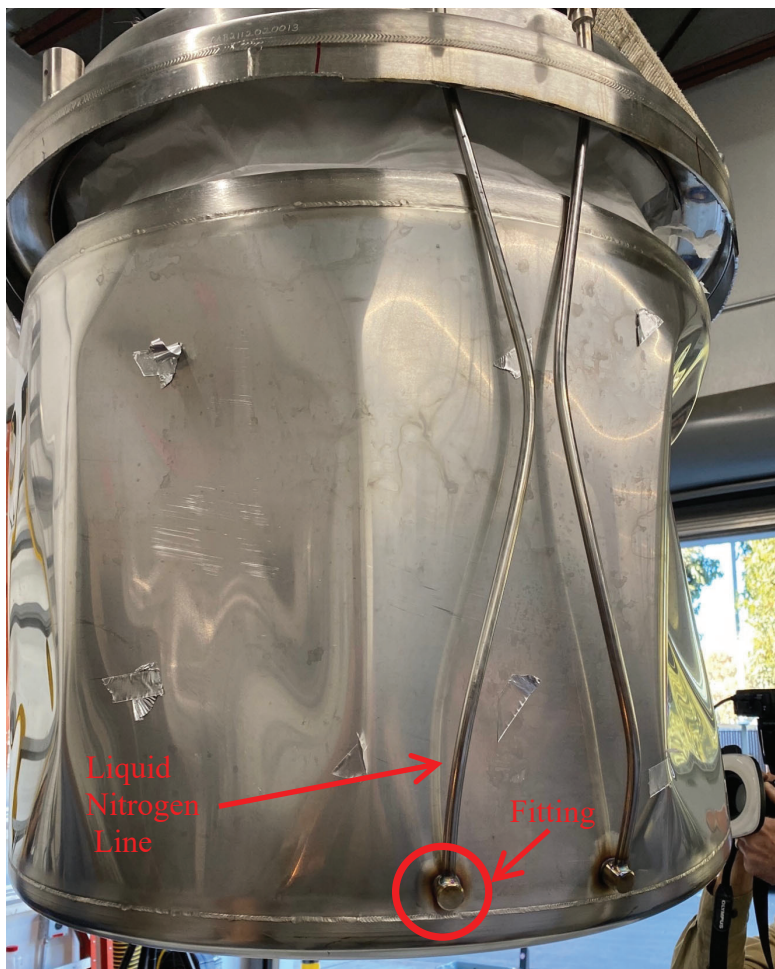
24. Tank 4 was manufactured with a metal tube that is used to refill the tank with liquid nitrogen. The tube ran from the top of the tank, down through the vacuum space between the inner and outer vessel, and then into the inner vessel near the bottom of the tank.

25. The picture below was taken after the outer vessel of Tank 4 was removed. The liquid nitrogen tube is on the left and the red circle shows where it connects to the inner vessel through a fitting.

Liquid nitrogen tube feeds into Tank 4's inner vessel
